"LESSONS FOR ROWERS"

from the Dove Pier Incident on 7th October, 2006

A report to the Thames Regional Rowing Council of the Amateur Rowing Association by:

29 February 2008

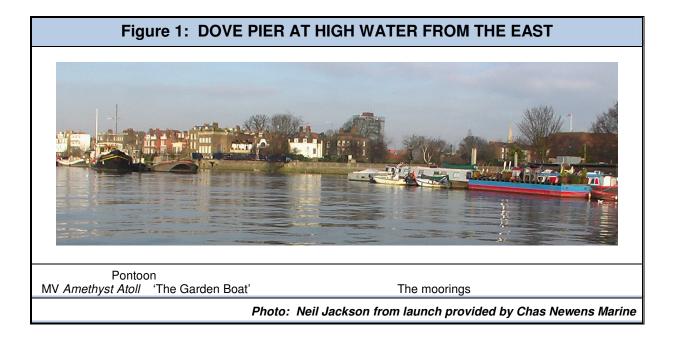
1.1 On Saturday, 7th October, 2006 a major rowing tragedy was avoided by the slimmest of margins. At about Noon that day, the Thames Rowing Club (TRC) racing boat, 'HRH Prince Michael of Kent', crewed by a novice women's eight (NW8+), and its accompanying out-board coaching launch ("tin-fish") were wrecked on Dove pier Hammersmith, west London. The wreck site was at the east, down-river end of Dove pier where the motor vessel (MV) Amethyst Atoll is moored to the end of the outer, southern face of the pier pontoon which projects out to the fairway (the deeper, central, fast-flowing part of the river). An unnamed lighter – "the garden boat" – is moored to the inner face of the pontoon - Figure 1.

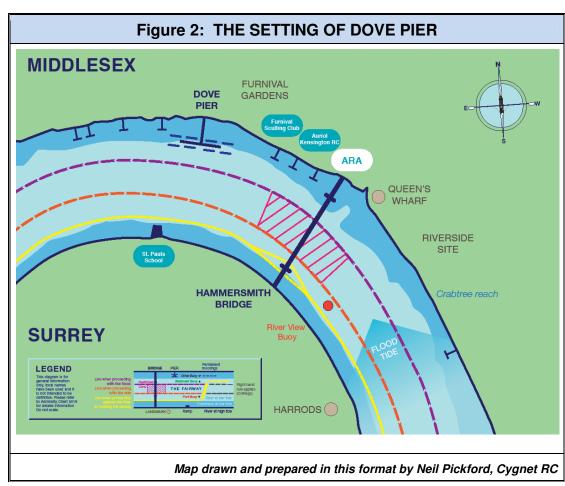
1. 2 Dove pier is located on the Middlesex side of the traditional rowing reaches of the tidal

Thames
("the
Tideway")
some
500m upriver from
Hammersmith
bridge. Its
pontoon is
joined by a
footbridge
to the river
wall -

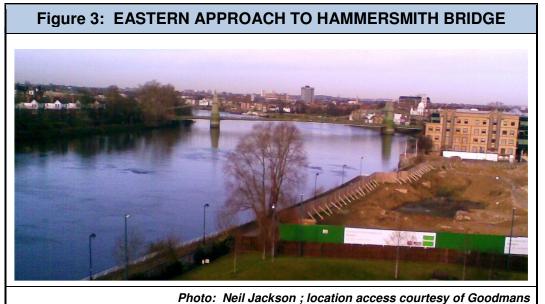
1.3 The NW8+ approached the pier from the east, travelling in the same direction as the in-

from
Putney,
through the
centre arch
of Hammersmith
bridge, and
onto Dove
pier. Figure
3 gives a

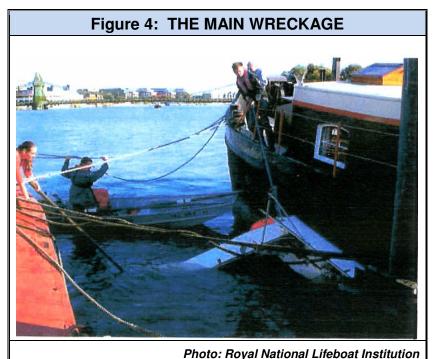
occurred when the flood tide carried the eight at an angle onto the bows of the *Amethyst Atoll*. The NW8+ then swung across its bows and onto the bows of the 'garden boat'. As the NW8+ broke up under the stresses, portions of it were forced into the space between the two moored boats and the pier pontoon – Figure 4.

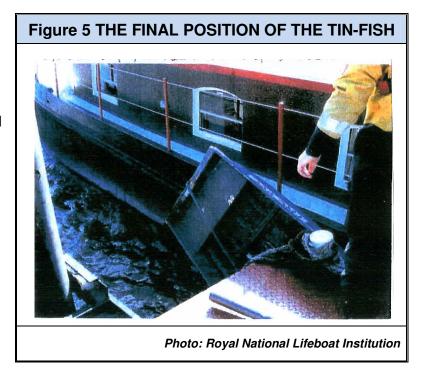
1.5. **The tin-fish** driver And coach attempted a rescue but were swept onto the wrecked NW8+ and swamped. The tin-fish ended up wedged between the pontoon and the *Amethyst Atoll* – Figure 5.

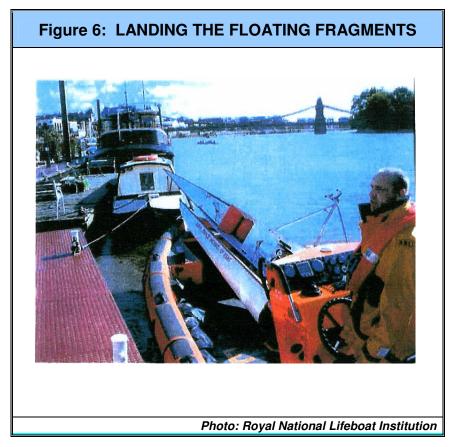
- 1.6 **11** rowers were now at very high risk of drowning. One individual went under the pontoon and three others went away into the river on the bow and stern portions of the broken boat. The remainder of the crew, the coach and the tin-fish driver found initial sanctuary on the mooring ropes and debris between the pontoon and the moored vessels.
- 1.7 Fortunately for the individuals, all 11 were rescued. The owner of the Amethyst Atoll was at home, heard the incident and was able at once to begin to help most victims onto his boat. Other rowing coaches with their launches saved those swept away. The Royal National Lifeboat Institution (RNLI) in-shore rescue boat, summoned by a "999 – Coastguard" phone call, attended. And recovered the wreckage of the eight - Cover and Figure 6.

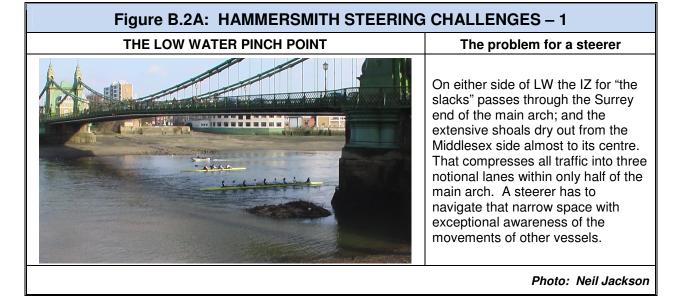
- (a) The transit of Hammersmith
- B.2.1 **Hammersmith bridge and its approaches** offer a cox, steersman or sculler ("steerer") a number of challenges varying with the height and direction of the tide Figure B.2. The river is over 200m wide from bank to bank (Code, page 50). The bridge's central span is about 120m wide. The Middlesex arch is never used by rowers, even at HW.
  - B.2.1.1 The Surrey arch is used by crews working the slacks except when it dries out on either side of LW creating a pinch point Figure B.2A.

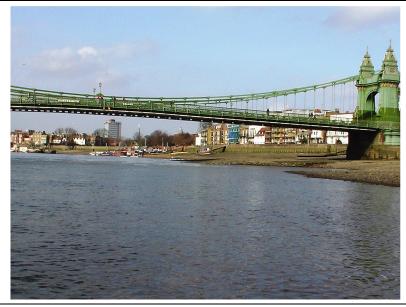
# Figure B.2B: THE HAMMERSMITH STEERING CHALLENGES - 3

B.2.1.2 High on the tide, including the phase of the flood tide equivalent to that when the Dove pier incident happened, the problem is an excess of space within the main arch but with the crucial boundary between the fairway out of sight under metres of water without any markers – Figure B.2B.

The upper shot attempts to replicate from the exposed edge of the Middlesex shoals at LW approximately the same perspective as the lower one taken from a launch at HW on the flood tide. From mid-tide to HW and back, the river covers all shoals with water deep enough for rowers from bank-to-bank. Steerers on starboard station on a flood tide must then estimate their route along the fairway within the full width of the centre arch water without immediate lateral guides. (Note from the upper shot that Dove pier is readily visible from many metres east of the bridge.)

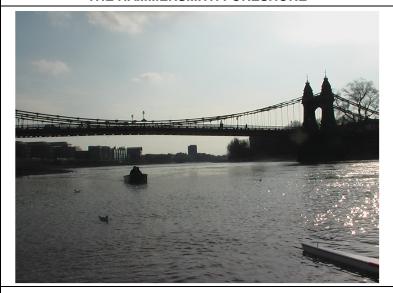
#### THE HAMMERSMITH FORESHORE

Between the bridge and Dove pier, steerers in transit must make allowance for rowing vessels (like the tin-fish and boat shown here) leaving from, or returning to, the ARA, AKN and FSC rafts. On either side of LW (as in this picture), such vessels have to use the edge of the exposed shoals by those rafts. That edge is more than 30m out from the river wall.

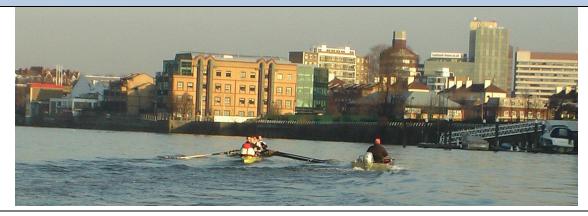
B.3A Passing Riverside pier: The QBC M8+ and tin-fish are on starboard station in the fairway, well clear of the pier, and at the start of the Hammersmith bend

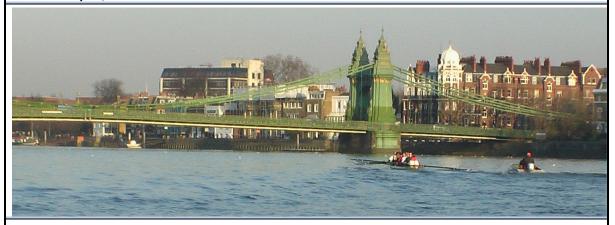
B.3B Queen wharf. The M8+has made a part-turn, along the fairway edge.

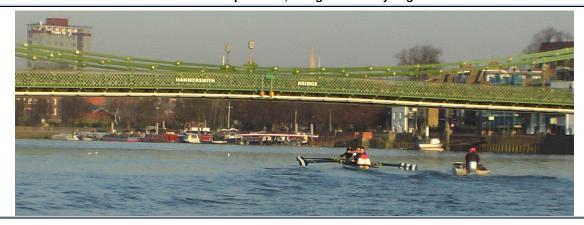
B.3C Lining up the passage of the bridge. Dove pier is clearly visible beyond the bridge.

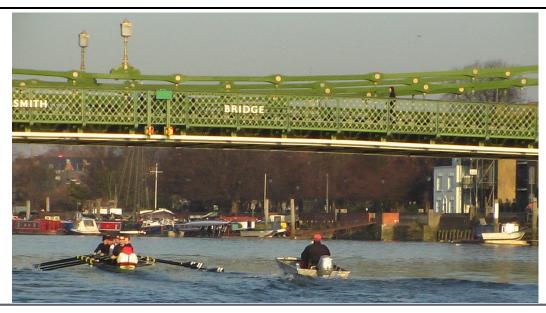
B.3D "Under the name of the bridge": clear of the Hammersmith foreshore; pointing past Dove pier.

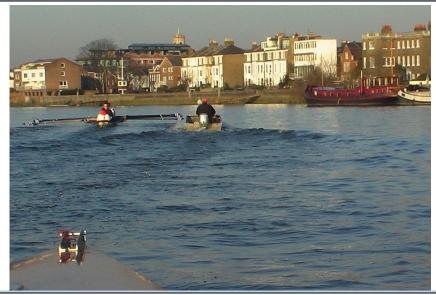
**B.3E** Passing Dove pier (by a safe margin)
