Safety Alert 3

Close the Gate

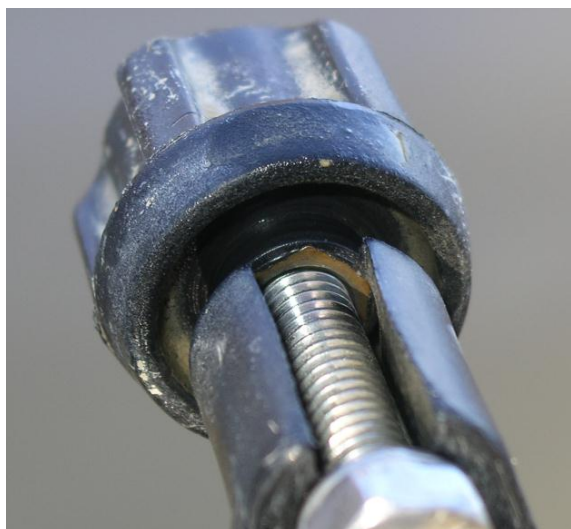
The design of the securing mechanism on traditional gates incorporates a nut with a circular groove or recess and a cylindrical collar that fits around the top bar, as shown below.

It is important that the nut is tightened in such a way that the collar is held in the groove in the nut.

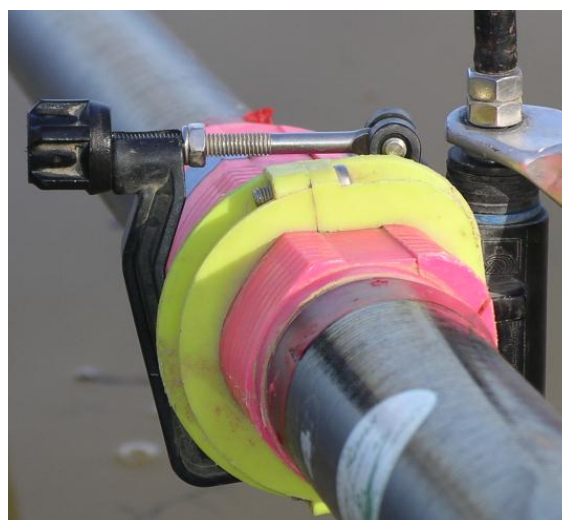
Incorrectly closed (the nut at the end of the top bar is tightly closed against the end of the cylindrical collar that surrounds the top bar but the cylindrical collar is not fitted into the groove in the nut).

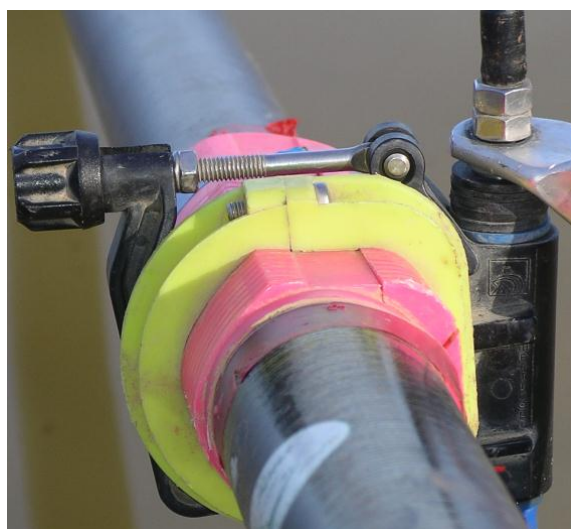
Incorrectly closed (the nut at the end of the top bar is not tightly closed against the cylindrical collar that surrounds the top bar).

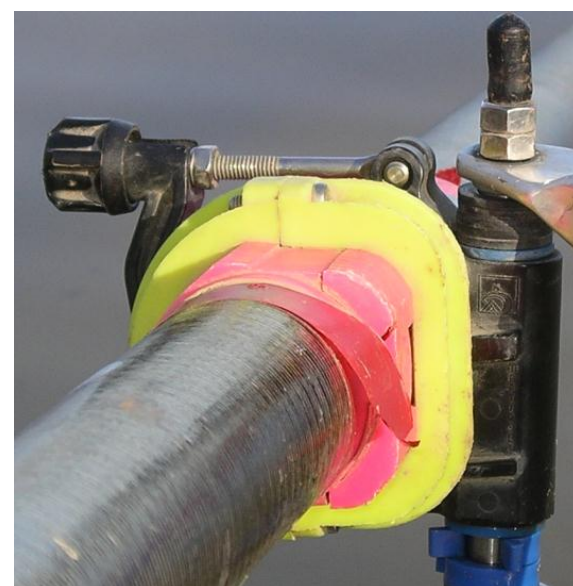
Gate closed correctly.
